CASE STUDY

Horse Heaven Mine Site Jefferson County, Oregon

**Prepared by
The Interstate Technology & Regulatory Council
Mining Waste Team**

HORSE HEAVEN MINE SITE, JEFFERSON COUNTY, OREGON

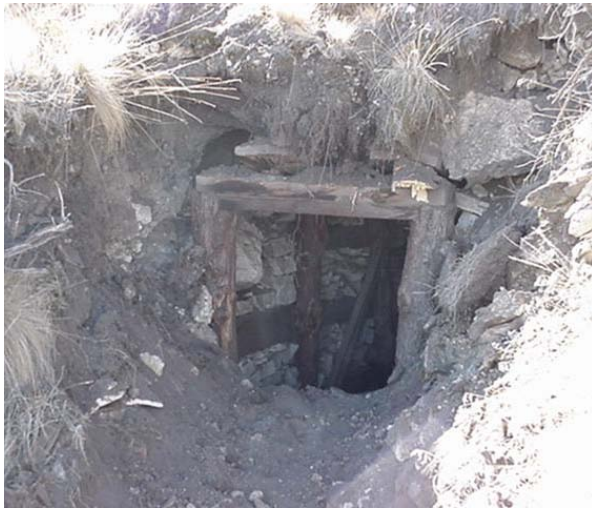
- Promote overall protection of human health and the environment.
- Prevent the tailings from being moved offsite by the public.
- Prevent the potential for off-site transport of the tailings via storm-water runoff.
- Remove mine dump refuse that was deposited off site.
- Protect the public from physical hazards associated with mine portals (Figures 2-1 and 2-2).
- Protect any suitable bat habitat associated with mine portals.

Figure 2-1. Unprotected mine portal.

- Excavation and on-site entombment and capping of D-furnace area soils
- Collection, entombment, and capping of solid waste mining debris on site
- Regrading of calcine tailings to mitigate mass wasting and off-site migration
- Abatement and mitigation of physical hazards represented by extant mine portals
- Construction of storm-water retention basins (Figure 2-3)
- Conservation of bat habitat (Figure 2-4)
- Institutional controls concerning use and access restrictions

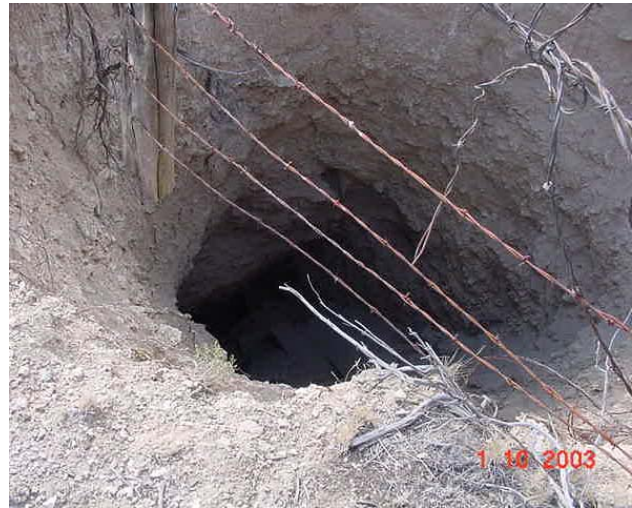
Figure 2-2. Dangerous open glory hole at head works.

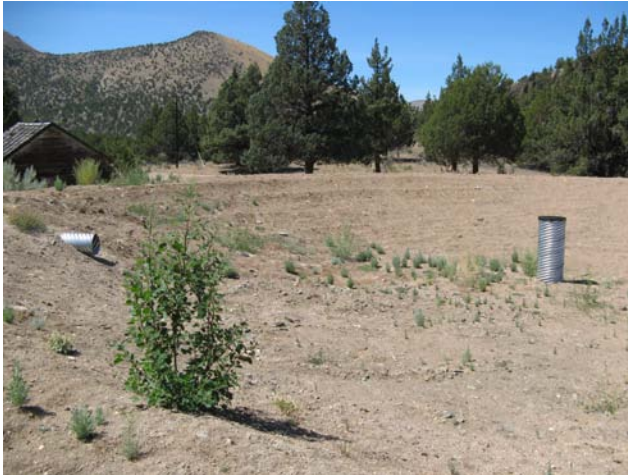
Figure 2-3. Storm-water retention basin.

Capping includes placement of alluvial sediments over a limited area associated with the D-tube furnace that had been documented to have elevated concentrations of mercury. Two settling ponds were also constructed for site storm-water retention. These retention basins were designed to eliminate any off-site migration of mine tailings.

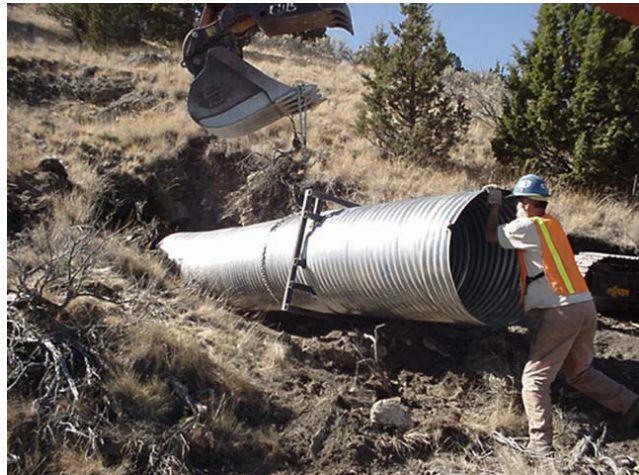
Figure 2-4. Installation of bat gate in mine portal.
