CASE STUDY

Kerramerican Mine Site Hancock County, Maine

**Prepared by
The Interstate Technology & Regulatory Council
Mining Waste Team**

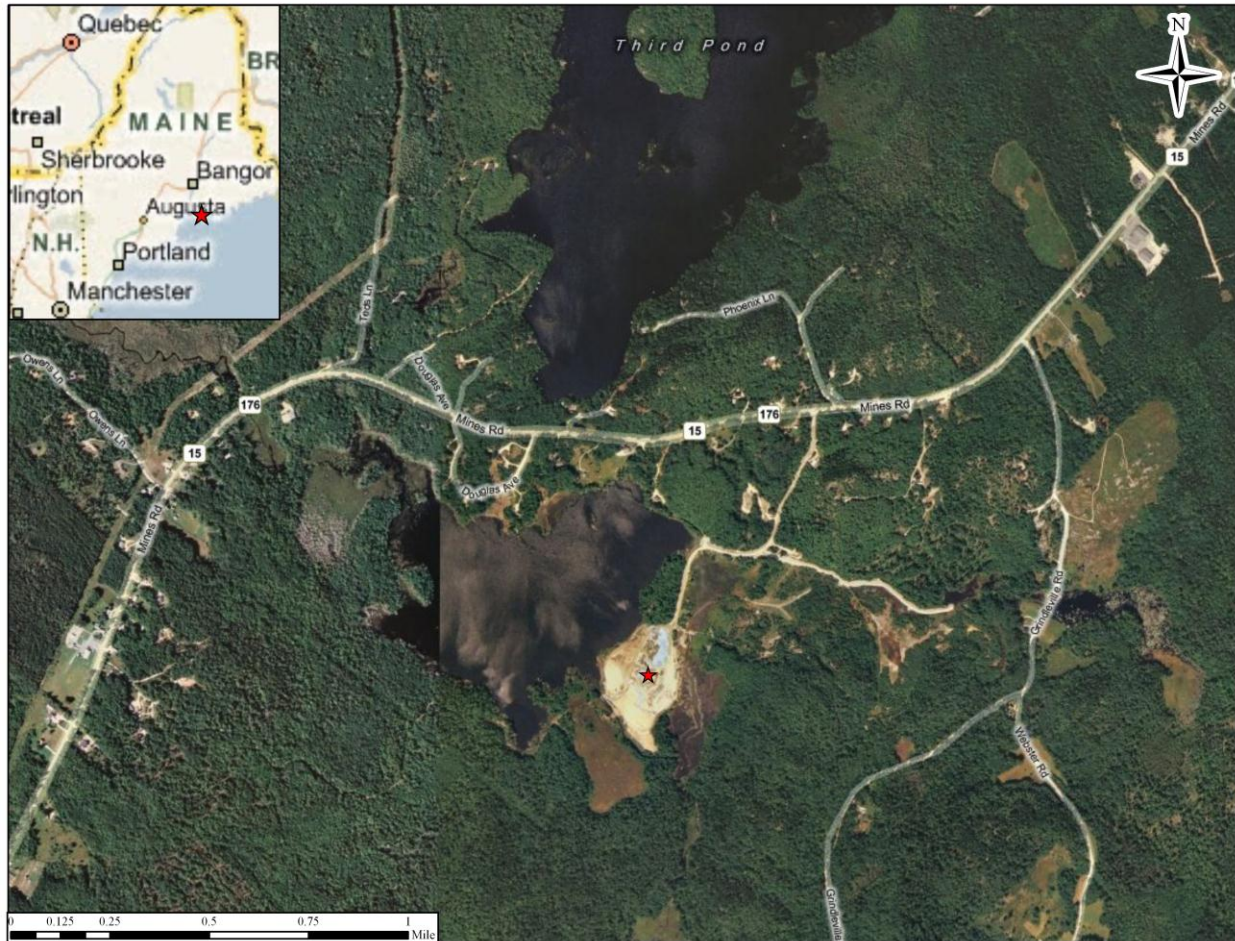
Figure 1-1. Kerramerican Mine Site. Created with ESRI ArcView software using Microsoft Bing maps.

The Kerramerican Mine property is located along Route 15/176 in Blue Hill, Hancock County, Maine (Figure 1-1). The property is owned separately by DLM Associates and two private owners. The zinc and copper mine, which operated 1971–1977, was officially closed under an agreement with the Maine Department of Environmental Protection in 1981. An on-site access road forms the border between a mill process area and a waste disposal area on the property. The 53-acre waste disposal area consists of two former tailings ponds that have been covered with till and vegetation. The mill process area was formerly occupied by a hoist house, former service and concentrator buildings, foundations of former thickener units, and the headframe of a mine shaft. Three unnamed intermittent streams and Carleton Stream flow through the property. The property is bordered by Second Pond to the west, Carlton Stream to the south, and sparsely developed residential properties to the east and north.
