CASE STUDY

Magmont Mine Site Iron County, Missouri

**Prepared by
The Interstate Technology & Regulatory Council
Mining Waste Team**

MAGMONT MINE SITE, IRON COUNTY, MISSOURI

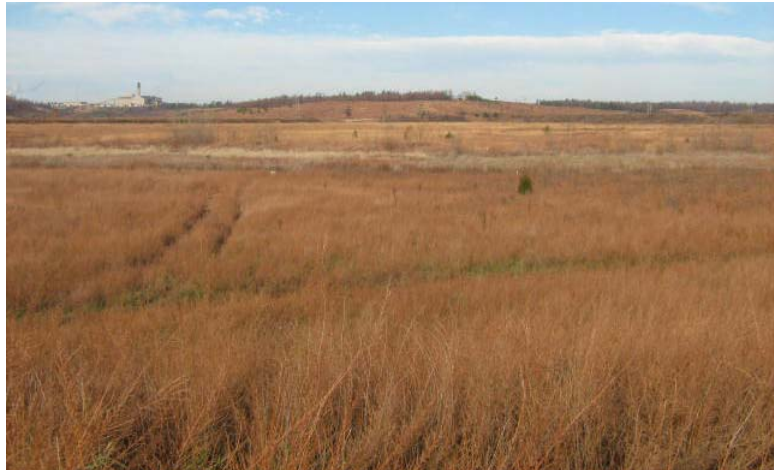
Figure 2-1. A reclaimed tailings impoundment at Magmont Mine.

As part of the reclamation, the tailings material was capped with 2–6 feet of clay material extracted from nearby hills surrounding the site. The soil from the adjacent side slopes is characterized as Clarksville very cherty silt loam with a moderately rapid permeability in the upper profile (2.0–6.0 inches per hour) to moderate permeability in the lower profile (0.6–2.0 inches per hour). The permeability of these soils allows for adequate infiltration of water into the covered tailings further minimizing runoff. Following placement of the soil, the surface of the tailings pond was disked, seeded, and fertilized. The planted vegetation was selected to establish a vegetative cover that is diverse, effective, permanent, capable of stabilizing the surface from wind and water erosion. Reclamation seeding was accomplished between 1992 and 1999. The mix of species planted included warm-season grasses, legumes and cool-season grasses, and woody vegetation (Figure 2-1). In addition to seeding, revegetation activities included annual applications of fertilizer and one controlled burn in 1998.

Drainage swales were constructed to direct surface-water flow across the site and minimize standing water on the tailings materials. The swales are useful in decreasing surface-water infiltration through the tailings. Rip-rap was installed along a northern drainage channel to preclude potential erosion during large rainfall or snow melt events. Grading activities undertaken to promote positive drainage with the waste management area have eliminated the majority of the open water areas of the site. A total of five open water areas, totaling 39 acres, remain.
